SWC TDR 62-144

SNAP 2/10A GROUND TEST PROGRAM, PHASE I

TECHNICAL DOCUMENTARY REPORT NUMBER AFSWC-TDR-62-144

March 1963

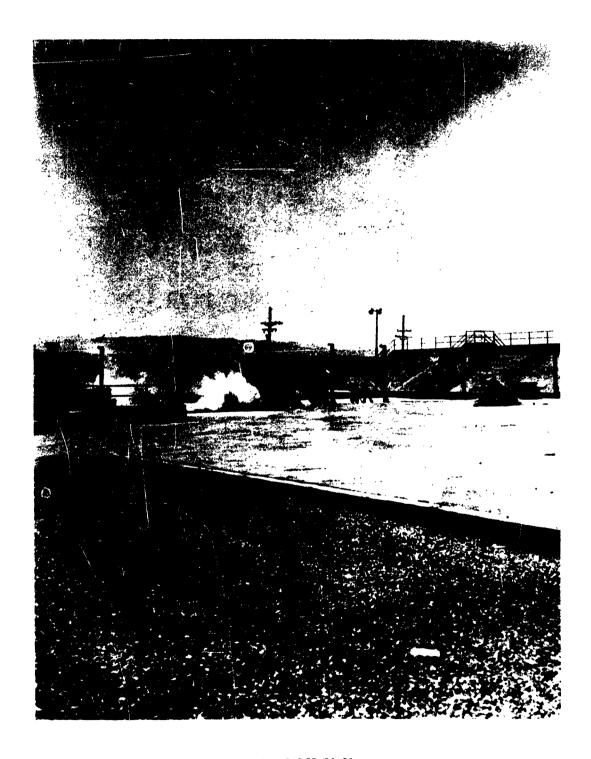
Figure 4. LOX-NaK test

Two seconds after the Squibs were fired to open the NaK lines, the LOX spray was initiated and was continued for approximately 40 seconds. Soon after the LOX spray was initiated, the NaK solidified, minimizing the initial reaction. Approximately 8 minutes after the LOX spray was terminated, the NaK began to liquify and flow from the core vessel. The NaK then reacted violently with water standing under the test stand (see figure 4).

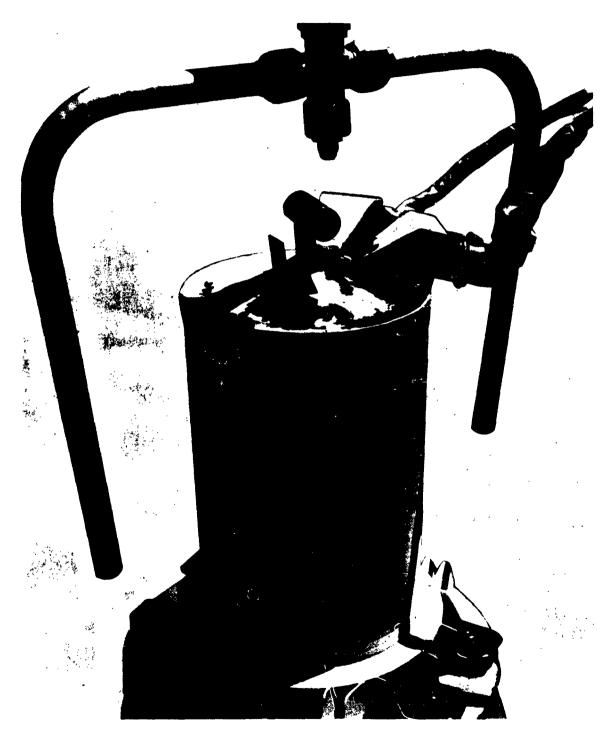
Figure 5. Reactor vessel -- post test

All recorders and cameras performed satisfactorily throughout the test. Visual examination of the reactor vessel after the test showed no external damage (see figure 5). Responses on the oscillograph tape were too small to interpret. It may be concluded that a SNAP 2/10A reactor vessel with open NaK lines will maintain its structural integrity when sprayed with

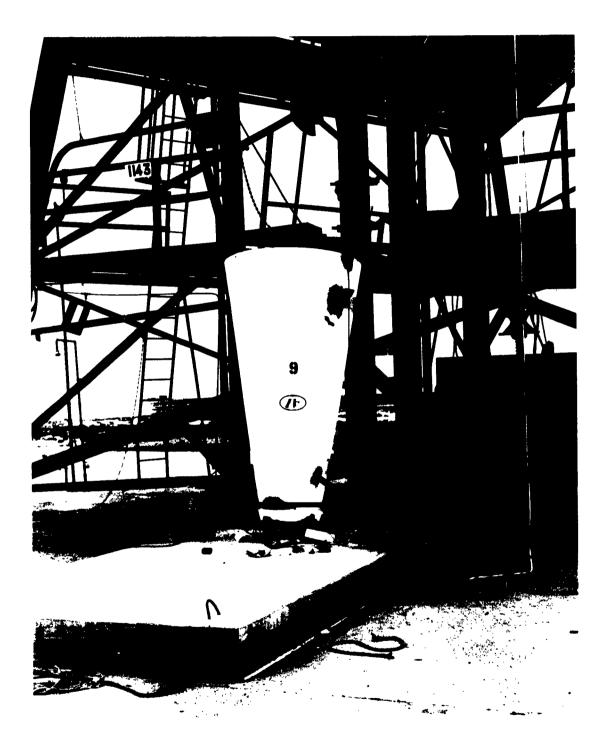
Figure 15. Reactor system -- post test

At 1500 hours on 12 July 1962 the nose-on, low-velocity, concrete impact test was performed. Upon impact, the four rotatable reflector drums were torn loose from their support structure and the brazed tension band snapped. However, the reflector halves did not separate from the core vessel. This was due to the fact that not only was the reactor driven back into the converter structure, but also the guidelines prevented toppling of the structure after impact (figure 15).

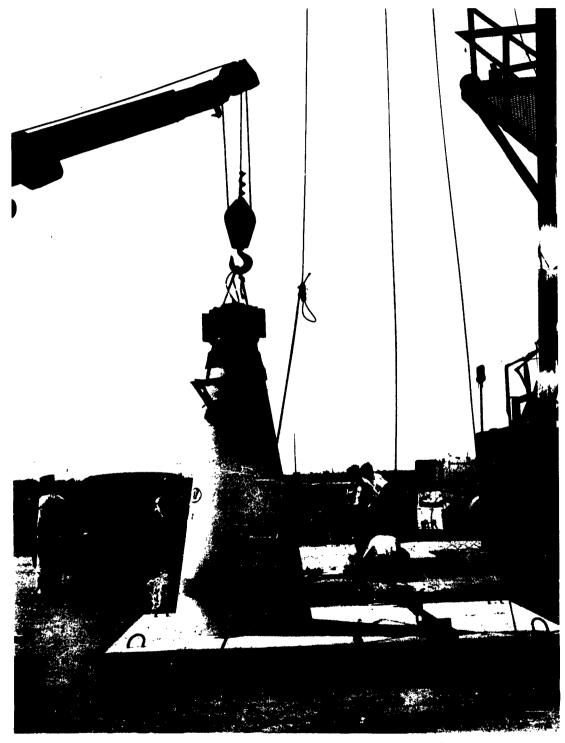
Figure 17. Low-velocity concrete impact: tail-on

The complete SNAP 2/10A system, consisting of the reactor vessel with simulated fuel rods, reflector assembly, shield, and converter structure, was impacted on the converter end of the assembly at 80 ± 10 fps (figure 17). The test procedure was the same as in Test No. 6.
